SERVICE INFORMATION LETTER

DATE 04 august 2017 SIL-005/ZSJ/2017

SUBJECT: Control of elevator pushrod fork tip

CONCERNS: SZD 9 bis Bocian 1E , D , C

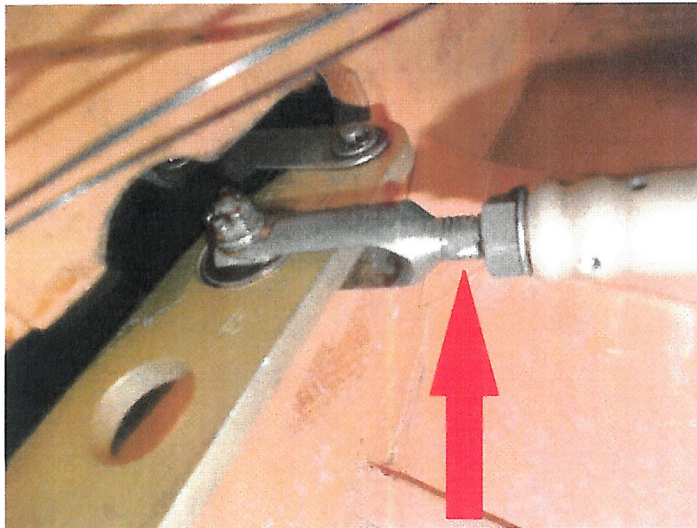
By the mirror or inspection camera check condition adjustable pushrod tip per circuit.

Any damage or curvature of tip eliminate possible to fly until replace the tip.

Please check protection of elevator during airfield transport. Unsafely elevator can provide to uncontrolled impact pushrod in to intermediate lever. This can entail curve or crack of tip Any repair or straighten pushrod fork tip is forbidden.
